CN54XX/CN55XX/CN56XX/CN57XX Pass 2 Known Issues

Version: 1.4

Last modified: 25 May 2010

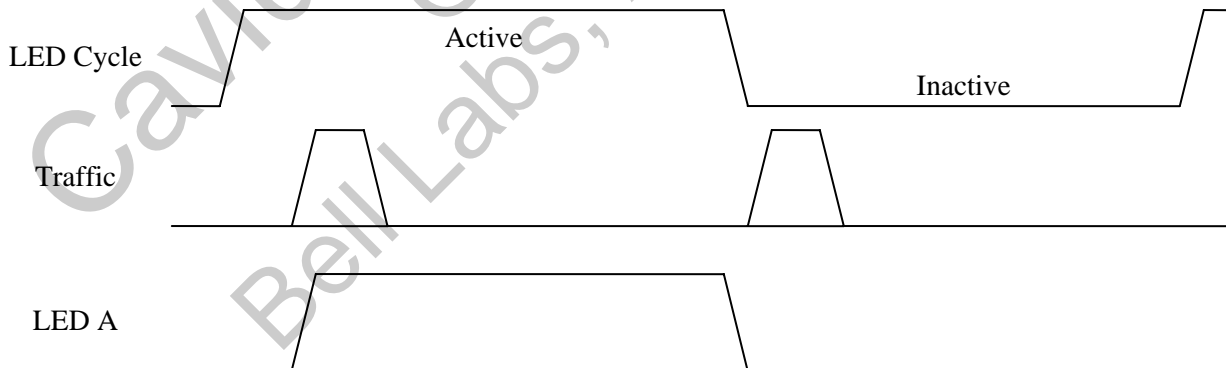
The figure below shows the case where traffic arrives shortly after the LED cycle enters the active state and more traffic arrives shortly after the inactive state. The LED will be on for most of the active period, and then off.

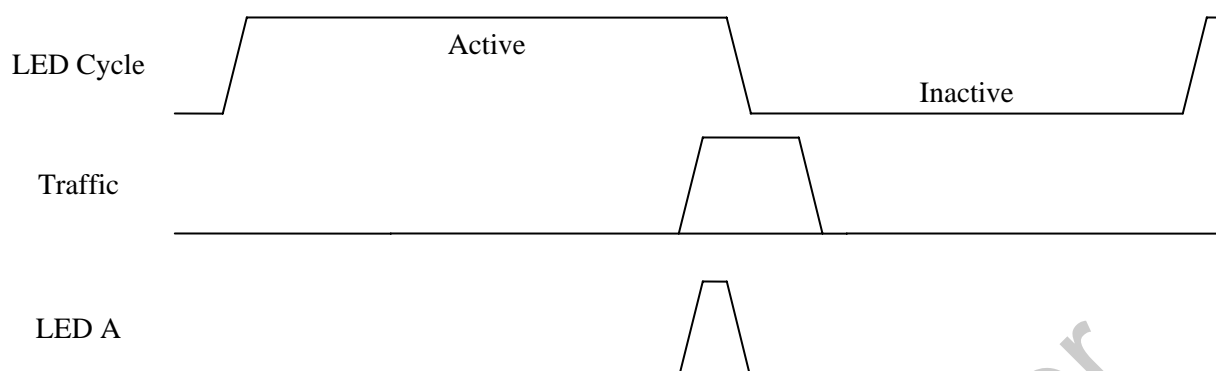
If port activity occurs during the inactive portion of the blink cycle, no LED indication will be provided at all. Further, traffic very late in the active portion of the blink cycle, while it may indeed turn on the LED, the LED will probably not be on for long enough to be detected by the eye, as shown in the figure below.

2.2.15.1.1 Workaround

Be aware of the potential for low duty-cycle blink displays.
