Mobile Intel® 965 Express Chipset Family Graphics Memory Controller Hub (G)MCH

Specification Update

March 2008

Revision 008

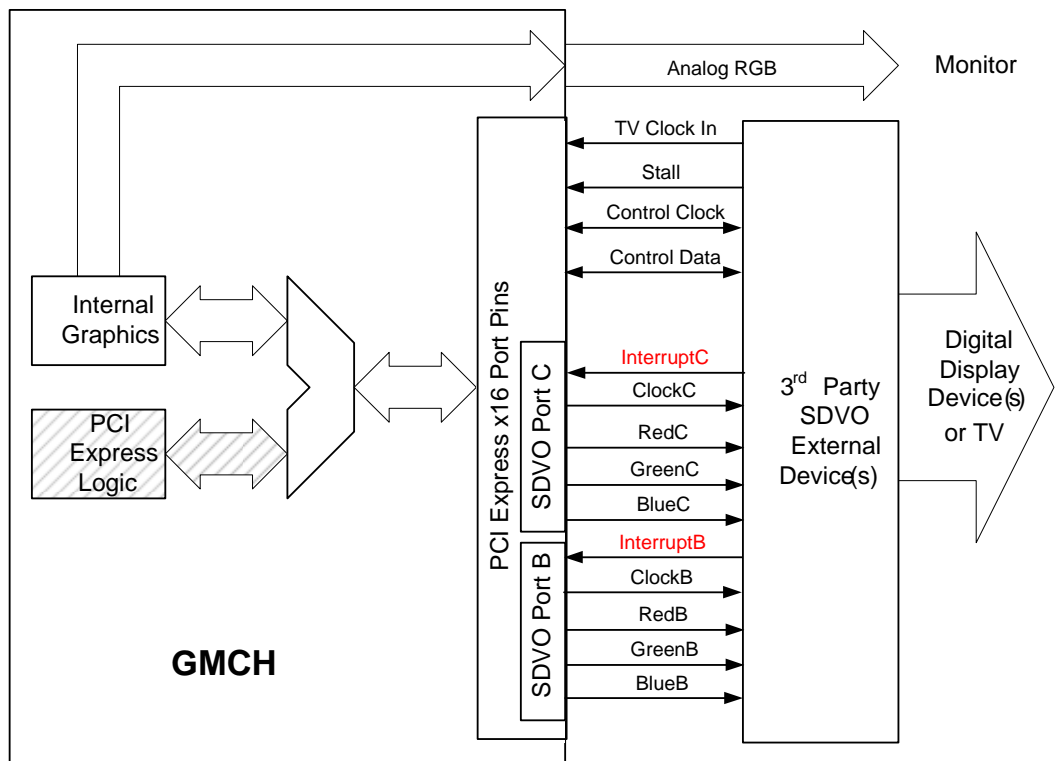
Section 6.3.1 Figure 10 SDVO Conceptual Block Diagram

2. SDVOB_INT and SDVOC_INT Signal Naming

Changes are in **RED** font.
