CN54XX/CN55XX/CN56XX/CN57XX Pass 2 Known Issues

Version: 1.4

Last modified: 25 May 2010

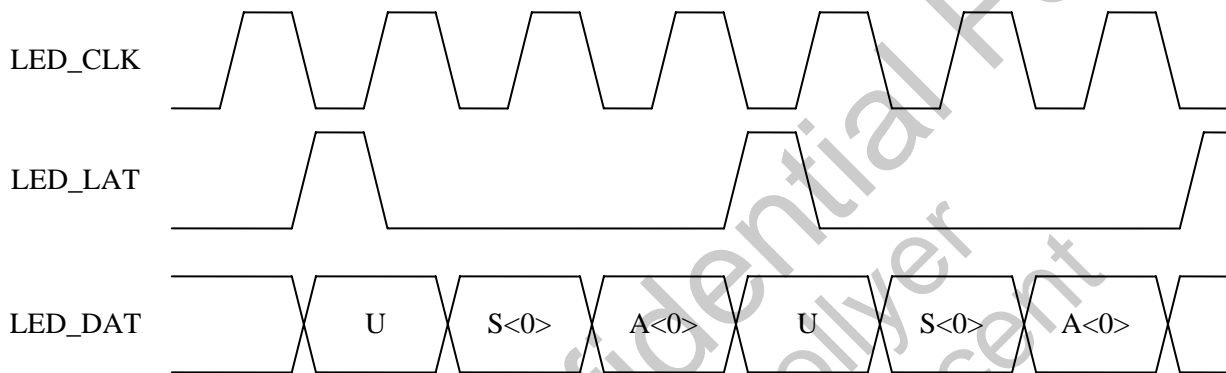
Consider the following diagram, which is the LED stream for a single-port configuration with LED_PRT_FMT[FORMAT] = 4, and no user data. S<0> is the port status for port 0, A<0> is the activity status for port 0. The data in the U cycle is indeterminate.

The LED blink cycle is split into two phases. During the active phase, any receive, transmit, or both types of traffic on the port in question (depending on configuration) will cause the activity LED to be turned on in the next LED_LAT cycle, and the LED will remain on until the inactive phase. During the inactive phase, the activity LED will be forced off.
